Technical Report 03-12

*Experimental Placement of Stone Matrix Asphalt
Project STP-8724 (00) X South Portland
January 2004*

Experimental Placement of Stone Matrix Asphalt

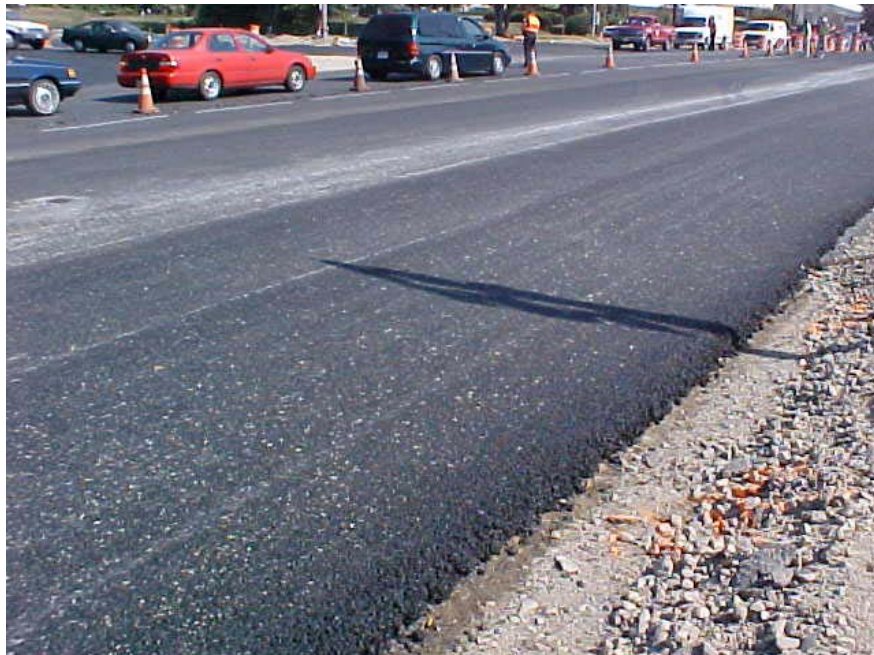
Photo 1: SMA Base

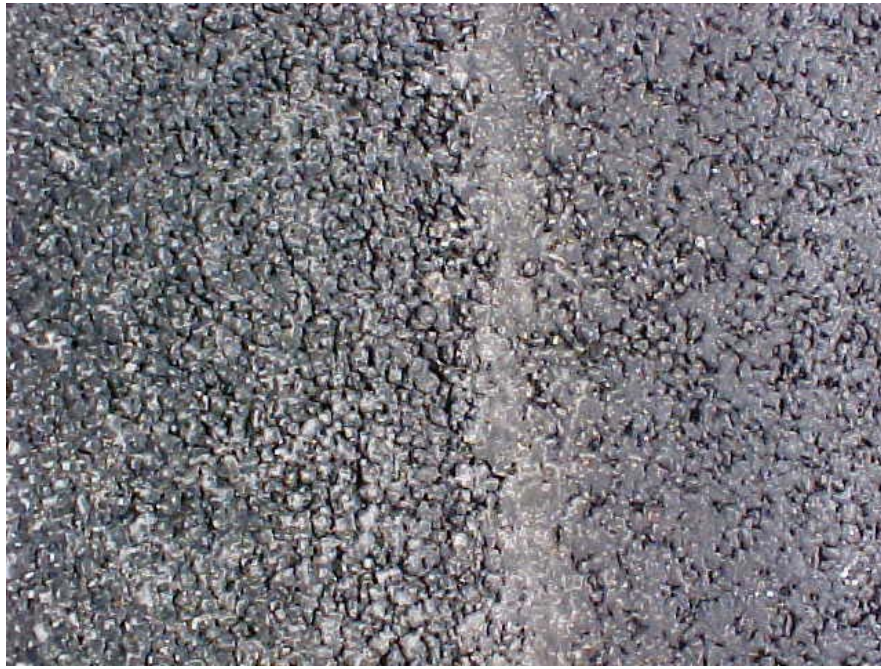
Photo 2: SMA Close-up (rolled)

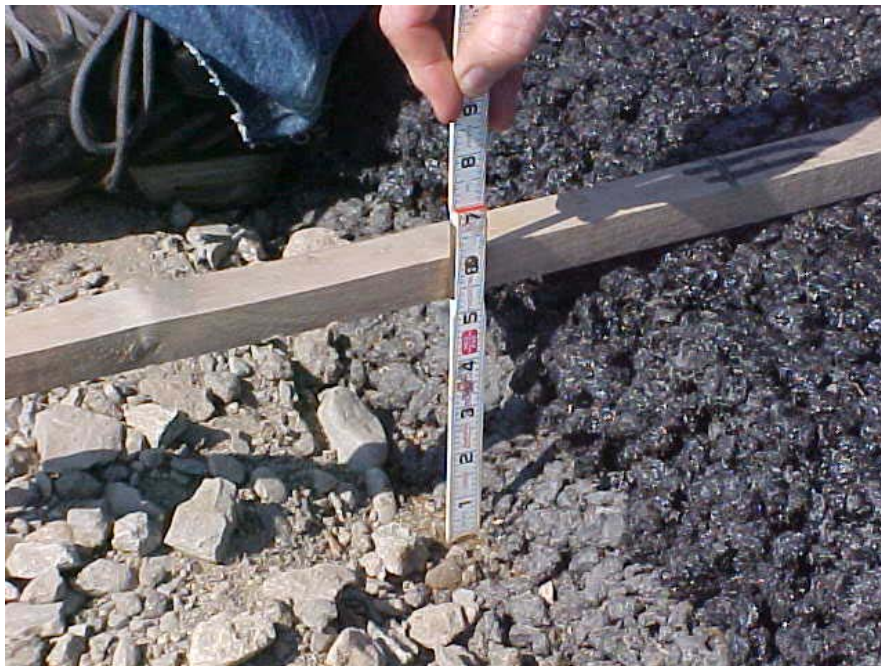
Photo 3: Depth of SMA base

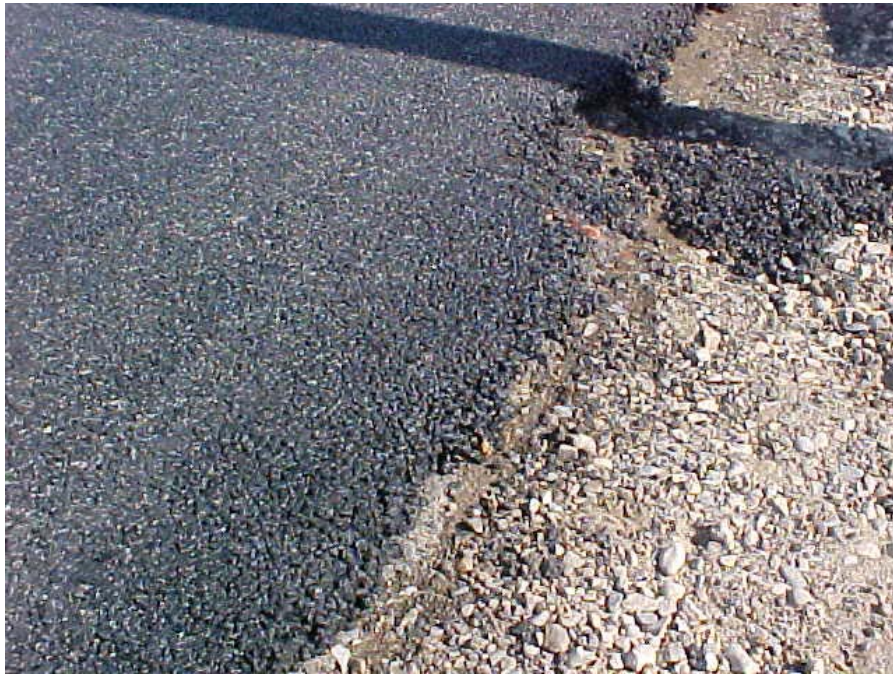
Photo 4: SMA squats on gravel

It should be noted that there were difficulties getting sufficient densities on the edges for the SMA. In order to maintain pavement shape, the edges were allowed to cool before compaction. When the SMA was being placed on the gravel there was more squatting than usual. Another note is that a small SMA shim was placed to account for a short dip in the intersection of Route 1 and Turnpike Spur, see Appendix C: Photo 8. The laboratory test results on both the SMA and the Superpave are located in Appendix A: Table 9 Laboratory Test Results. The SMA project specs are located in Appendix D.

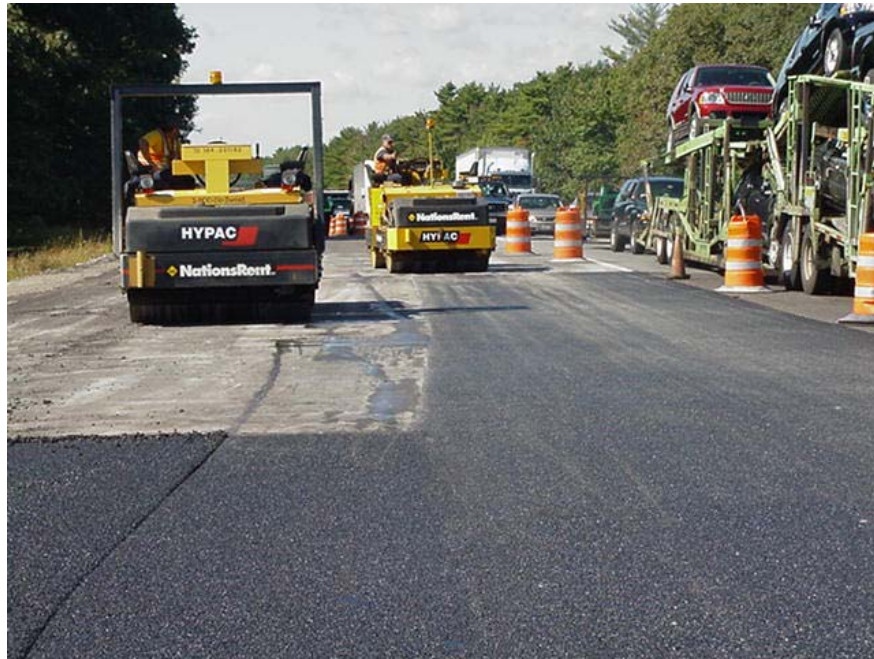
Photo 6: Route 1 and Turnpike Spur, right lane of T-section

The intersection of Route 1 and Turnpike Spur (703) consists of three different construction processes. The left side of the right lane of the T-section was milled 3 to 4 inches and then paved with SMA. The right side of the right lane of the T-section was redone using the modified Superpave. See Photo 6 in Appendix C for a view of the right lane of the T-section. The majority of the intersection of Route 1 and Turnpike Spur (703) was full-depth SMA. The existing pavement was removed and SMA was placed from station 11+160 to 11+260. A 150mm SMA base course, 19.0mm grading, followed by a 50mm wearing course, 12.5mm grading, was used between stations 11+160 to 11+260. A plan view of the SMA intersection is shown in Appendix B: Figure 4.

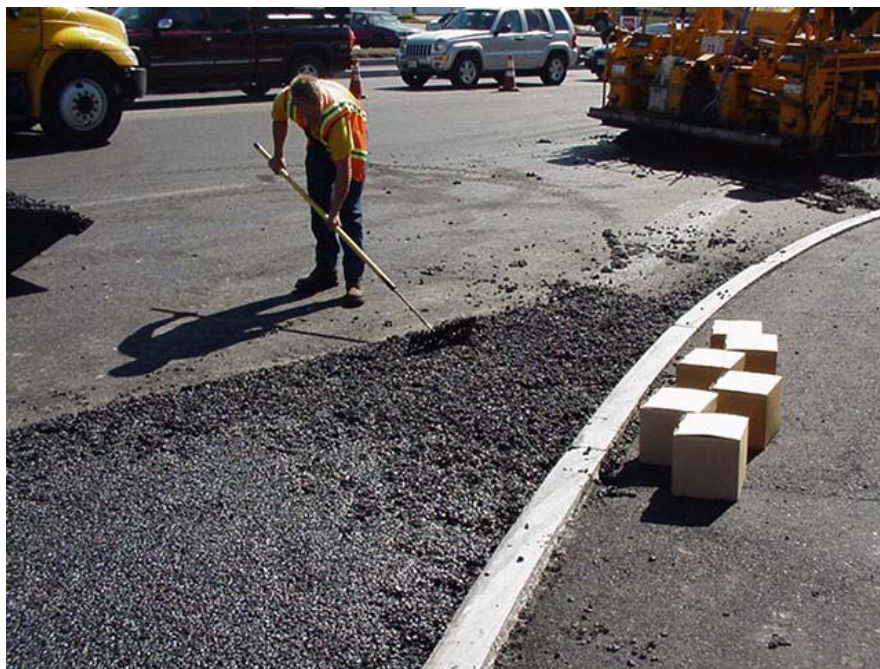
Photo 7: Some hand-place (same intersection as Fig 6)

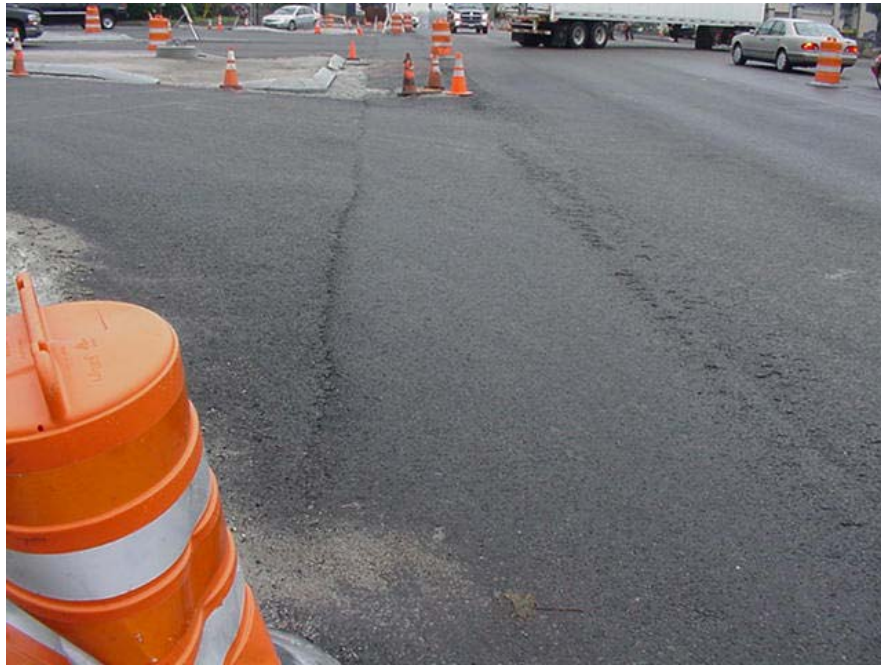
Photo 8: SMA 12.5mm Shim

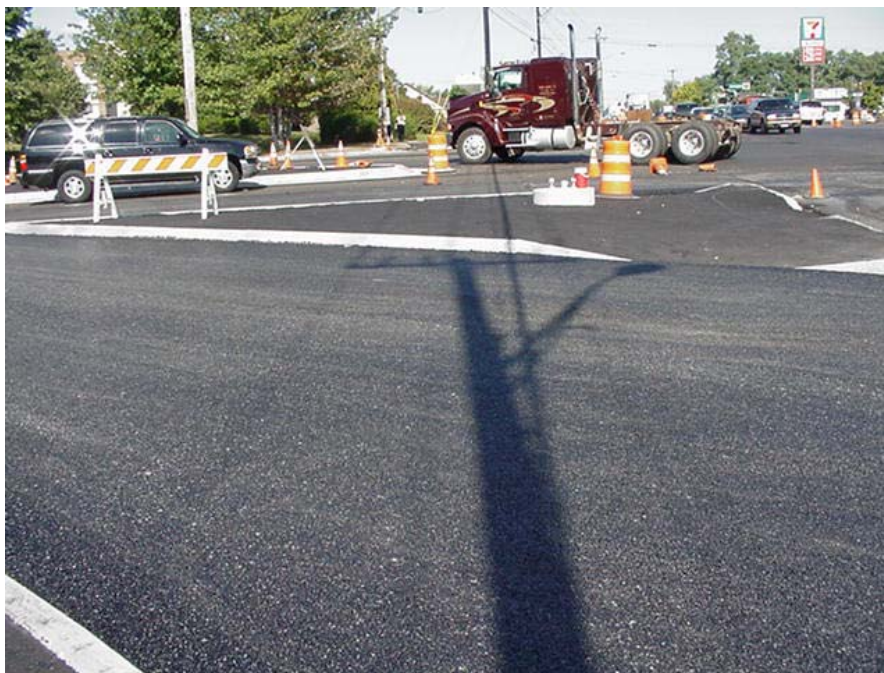
Photo 9: Finished SMA (same intersection and Fig 6 & 7)
